COLLECTION: ORGANIC BLOCKS

# SBI Test Report - EN 13823

Standard used	EN 13823:2010 + A1:2014
Date of test	26-04-2016
Full test duration/performed	Yes
Smoke correction performed	No
Report identification	OMC143A16
<b>Product</b>	
Product identification	organic Blocks
Sample number	1
Thickness [mm]	0
Mass per Area [kg/m²]	0

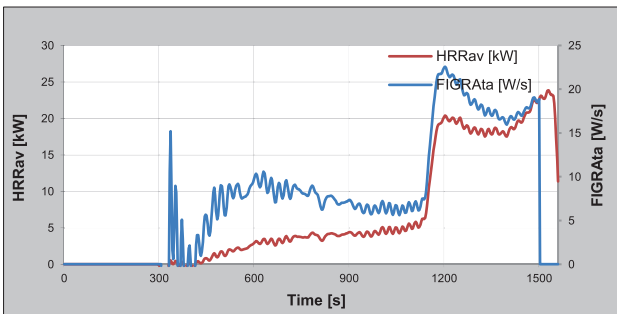
FIGRA_0.2 [W/s]	22,57		
FIGRA_0.4 [W/s]	22,57		
FIGRA [W/s]	22,57	B	B
THR600s [MJ]	1,49	B	
<b>Heat Release</b>

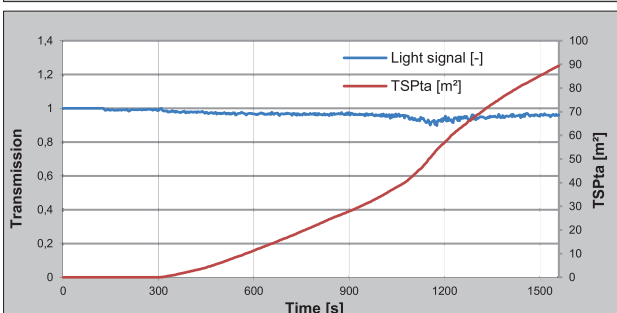
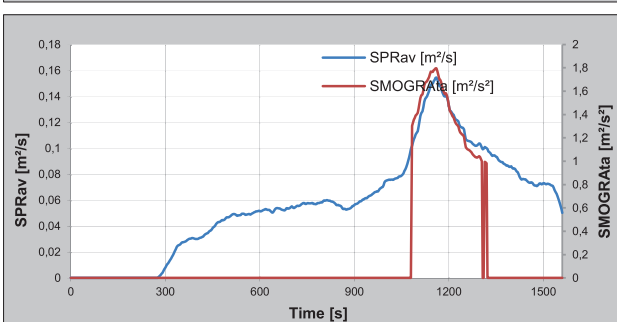
SMOGRA [m²/s²]	1,80	
TSP600s [m²]	27,86	S1
<b>Smoke Production</b>
